Analysis of Lighting Fixtures

MMR Project No. 82999

MassDOT
Boston, MA

April 5, 2011

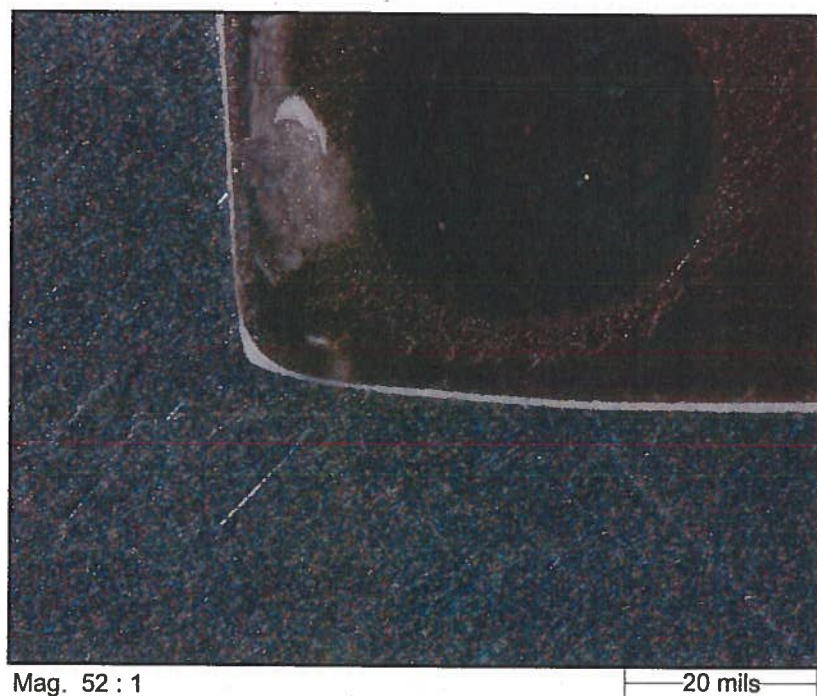
Figure 68: Sample #3: Schreader, new. Mount 3-2. Note the variation in coating thickness. This is the radius at the lip.

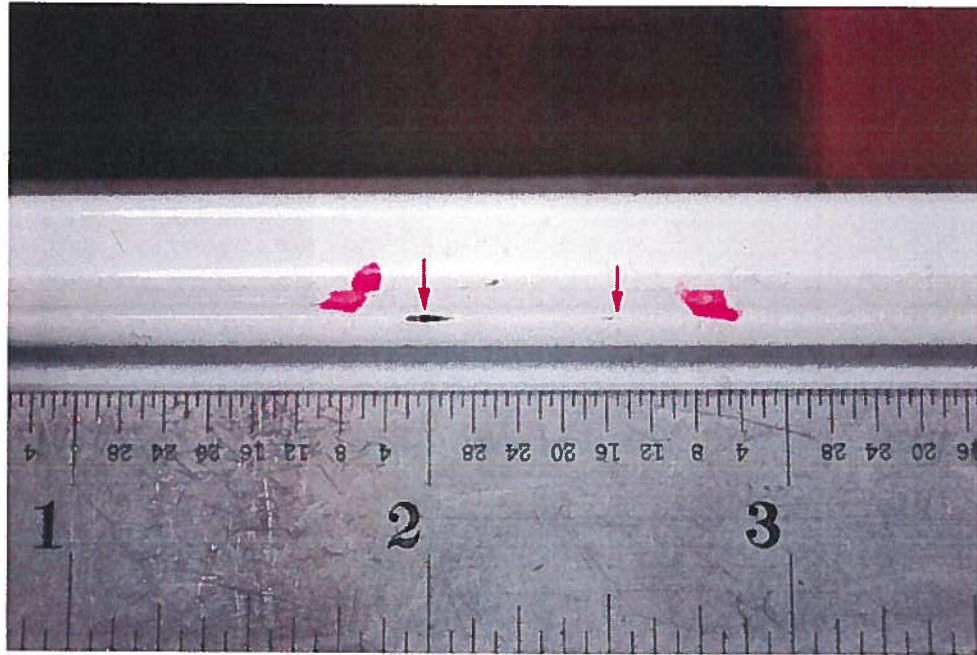
The new light fixture was assembled to the new wireway pieces, sample #2 (NuArt) and sample #3 (Schreader). The clips were attached with extreme care. It was noted that for both samples, the coating was abraded at the lip edge locations; the damage was greater for the NuArt sample than compared to the Schreader. Effort was needed to assemble the wireway to the light on the NuArt sample. The Schreader wireway assembled easily.

Figure 82: Sample #2 (NuArt): The wireway lip area after removal of the clip. Arrows point to the breached coating at the edge/corner. The coating was intact in this location before assembly of the clip.

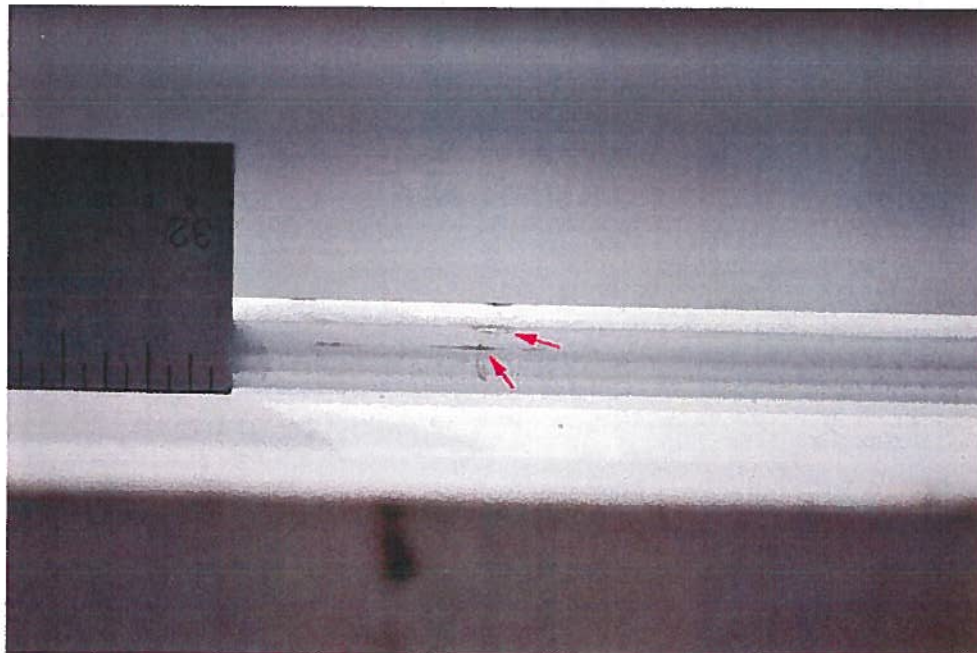
Figure 83: Sample #2 (NuArt): The same area as in the previous photograph showing the coating damage, arrows, on the underside of the lip after removal of the clip.

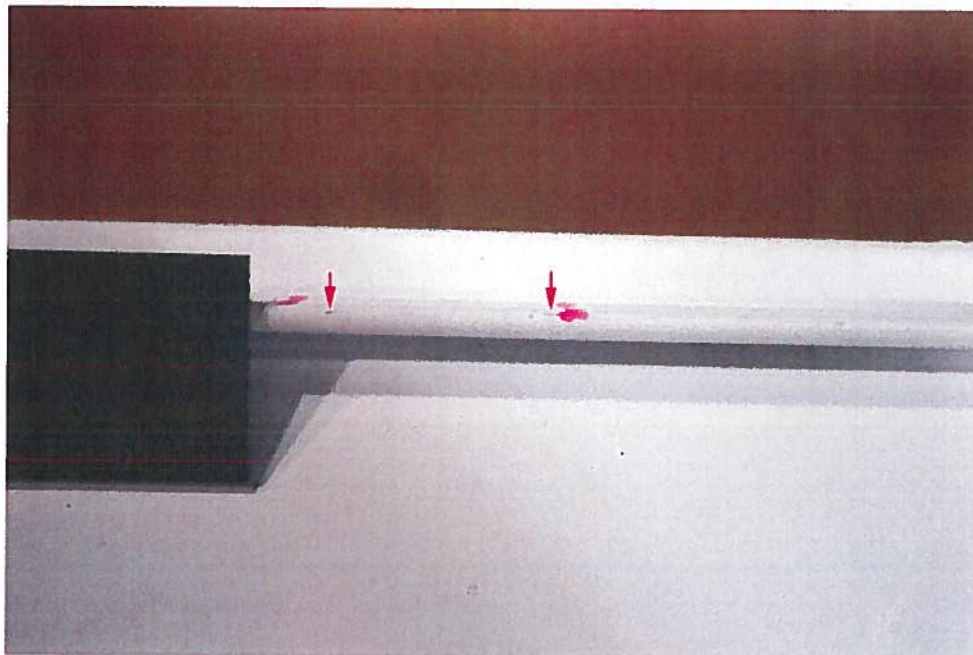
Figure 87: Sample #3 (Schreader): The same area as in the previous photograph after removal of the clip. The arrows point to the damaged coating at the lip edge.

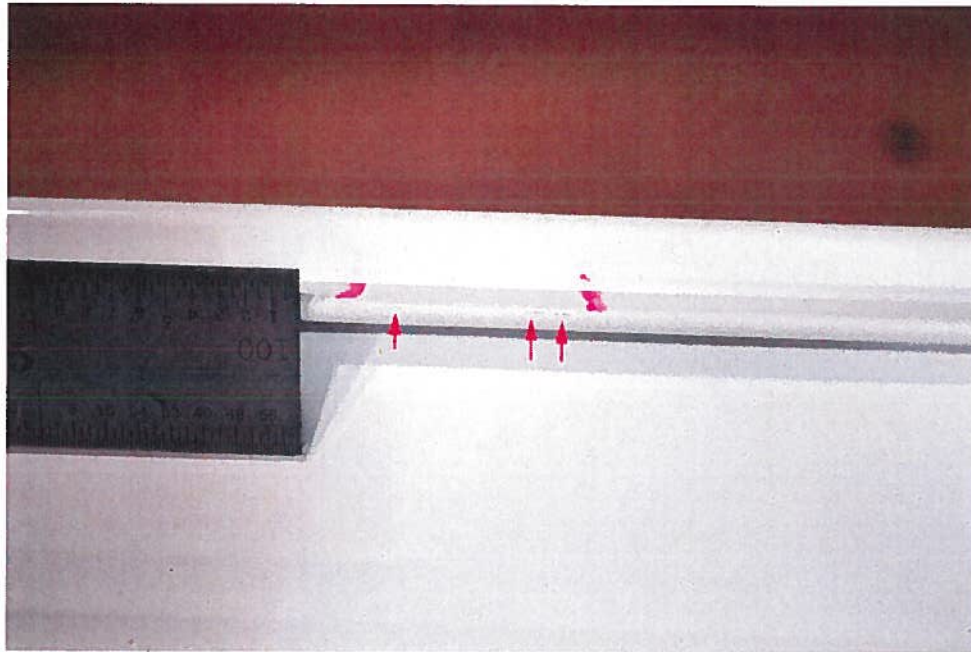
Figure 88: Sample #3 (Schreader): Another view of the area in Figure 87. Arrows point to coating damage.
